Manhole Inspection Summary

Manhole # S33CC_036MH

Insp Date: **1/27/08 10:39 AM**

Location Address: **READ ST**

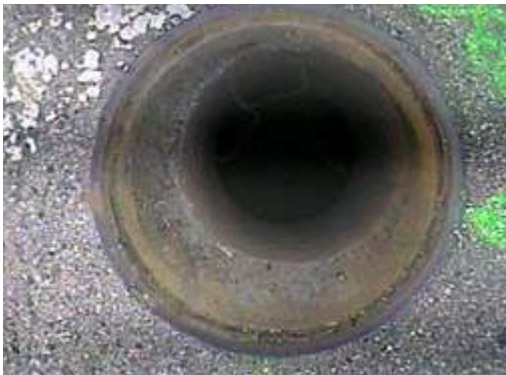
Top View

Offset: **8** (in.)

FRAME OFFSET

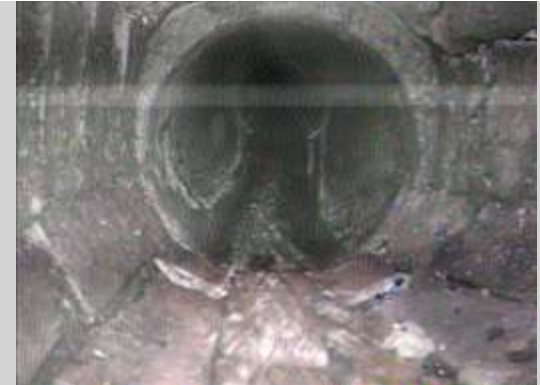
12 O'Clock Outflow

8 in. Circular Gravity Sewer
Pipe Out @ 12 O'Clock

Pipe Height: (in.) Direct
Pipe Material: **Clay** ☐ Pipe Lined
Invert Depth: **10.94** (ft.) Flow Characteristics: **Slow**
Deposits: ☒ None ☐ Mud ☐ Sludge ☐ Debris ☐ Grease
Silt Depth: (in.) Deposits Extent:
Infiltration: **None** Pipe Seal Cond: **Sound**

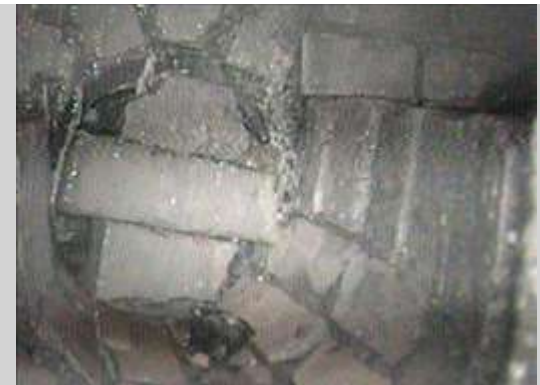
3 O'Clock Inflow

8 in. Circular Gravity Sewer
Pipe In @ 3 O'Clock

BRICKED SHUT.

Pipe Height: (in.) Direct
Pipe Material: **Clay** ☐ Pipe Lined
Invert Depth: **10.84** (ft.) Flow Characteristics: **None**
Deposits: ☒ None ☐ Mud ☐ Sludge ☐ Debris ☐ Grease
Silt Depth: (in.) Deposits Extent:
Infiltration: **None** Pipe Seal Cond: **Sound**

Connects To: **Stub connection / abandoned**

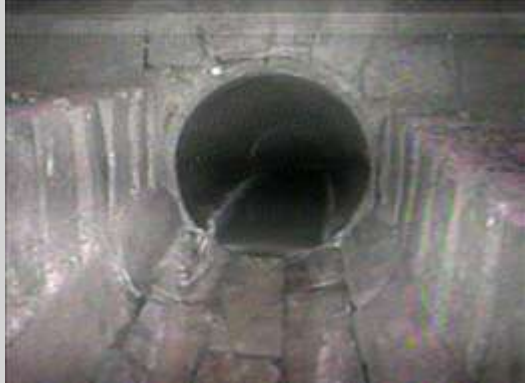
6 O'Clock Inflow

8 in. Circular Gravity Sewer

Pipe In @ 6 O'Clock

Invert Depth: **10.73** (ft.) Flow Characteristics: **Slow**

Infiltration: **None** Pipe Seal Cond: **Sound**
